**Flood Control Project Maintenance  
Levee Inspections**

## Maintenance Issue Types Only, Levee Inspection Report By Mile - Spring 2016

### Reclamation District No. 2103 Wheatland Vicinity

Waterway	Bank	Unit Miles	Inspection Start/End	Inspector
Unit No. 01 South Dry Creek	Left	4.64	04/26/2016 04/26/2016	Sterling York

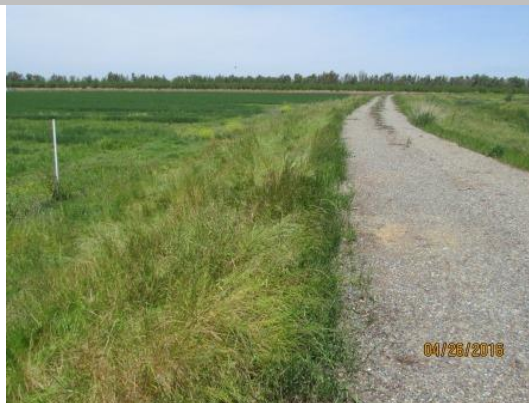
Photo 1 of 1 : SP\_2016\_RD2103\_10\_21\_20160427\_00038.jpg

LM Start	3.33	Rating **	M	Issue No.	21
LM End	3.53	Issue Type +	Ma	Location *	LS
Category	Earthen Levee			GPS Latitude/Longitude	
				Start	End
Item	Vegetation			39.032923 °	39.030269 °
				-121.400838 °	-121.401014 °
DWR ID	DWR_RD2103_01_s_2016_21				
Comment Code					
V1 : Control annual grass and weeds on the levee slopes and easements.					
Inspector Comment

View of vegetation on the landside slope looking upstream.

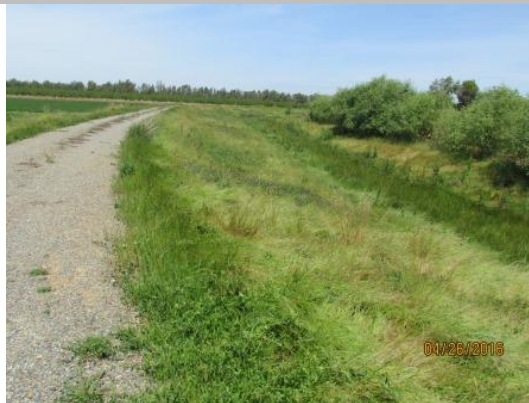
Photo 1 of 1 : SP\_2016\_RD2103\_10\_24\_20160427\_00039.jpg

LM Start	3.33	Rating **	M	Issue No.	24
LM End	3.53	Issue Type +	Ma	Location *	WS
Category	Earthen Levee			GPS Latitude/Longitude	
				Start	End
Item	Vegetation			39.032923 °	39.030269 °
				-121.400838 °	-121.401014 °
DWR ID	DWR_RD2103_01_s_2016_24				
Comment Code					
V1 : Control annual grass and weeds on the levee slopes and easements.					
Inspector Comment

View of typical vegetation on waterside looking upstream.

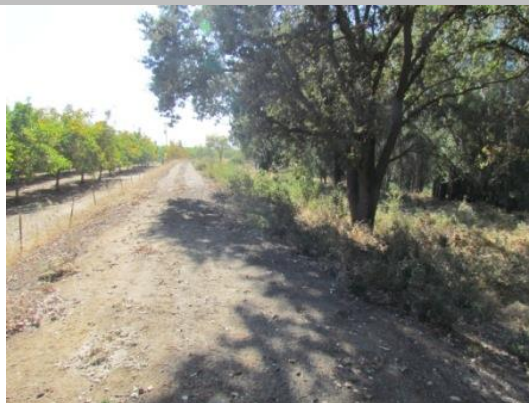
Photo 1 of 1 : SP\_2016\_RD2103\_10\_8\_20160307\_00003.jpg

LM Start	4.41	Rating **	M	Issue No.	8
LM End	4.49	Issue Type +	Ma	Location *	WS
Category	Earthen Levee			GPS Latitude/Longitude	
				Start	End
Item	Vegetation			39.041051 °	39.041810 °
				-121.394931 °	-121.393951 °
DWR ID	DWR_RD2103_01_f_2013_8				
Comment Code					
V2 : Remove the wild growth other than native grasses from the levee slopes.					
Inspector Comment

This photo was taken from the crown of the levee facing west looking at the vegetation on the waterward slope of the levee.

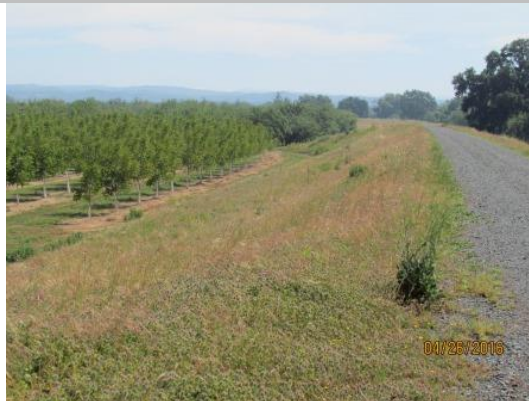
Photo 1 of 1 : SP\_2016\_RD2103\_11\_16\_20160427\_00031.jpg

LM Start	0.02	Rating **	M	Issue No.	16
LM End	4.73	Issue Type +	Ma	Location *	LS
Category	Earthen Levee			GPS Latitude/Longitude	
				Start	End
Item	Vegetation			38.993534 °	39.030268 °
				-121.436965 °	-121.368667 °
DWR ID	DWR_RD2103_02_s_2016_16				
Comment Code					
V1 : Control annual grass and weeds on the levee slopes and easements.					
Inspector Comment

View of typical vegetation on the landside slope looking downstream.

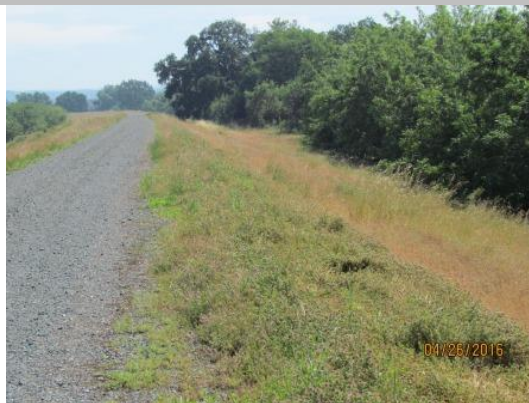
Photo 1 of 1 : SP\_2016\_RD2103\_11\_17\_20160427\_00032.jpg

LM Start	0.02	Rating **	M	Issue No.	17
LM End	4.73	Issue Type +	Ma	Location *	WS
Category	Earthen Levee			GPS Latitude/Longitude	
				Start	End
Item	Vegetation			38.993534 °	39.030268 °
				-121.436964 °	-121.368667 °
DWR ID	DWR_RD2103_02_s_2016_17				
Comment Code					
V1 : Control annual grass and weeds on the levee slopes and easements.					
Inspector Comment

View of typical vegetation on the waterside looking downstream.

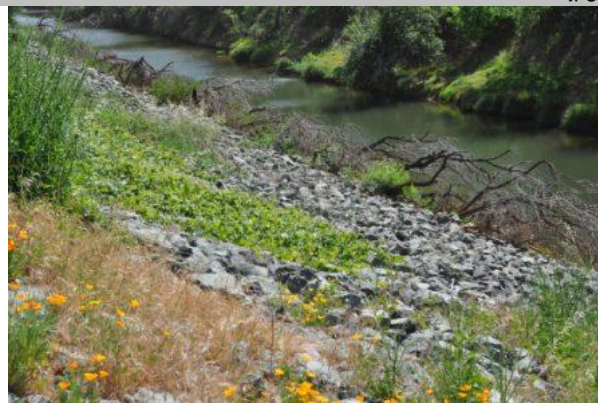
Photo 1 of 2 : SP\_2016\_RD2103\_11\_4\_20160307\_00001.jpg

LM Start	0.29	Rating **	A/W	Issue No.	4
LM End	0.50	Issue Type +	Ma	Location *	WS
Category	Earthen Levee			GPS Latitude/Longitude	
				Start	End
Item	Riprap Revetments			38.994660 °	38.995537 °
				-121.432170 °	-121.428535 °
DWR ID	DWR_RD2103_02_s_2012_4				
Comment Code					
Inspector Comment					
The District has a concern with dead trees placed in the rip rap that may not stay in place during a high water event.

View of revetment with dead trees, Spring 2013.
